CITY OF SAN JUAN BAUTISTA CITY COUNCIL/HISTORIC RESOURCES BOARD STAFF REPORT

AGENDA TITLE: **Action Steps to Address Public Safety Issues at 107
Third Street, La Casa Rosa**

Subject: 107 3rd Street, San Juan Bautista, California

Project: 107 Third Street, San Juam Bautista -
Consultaion

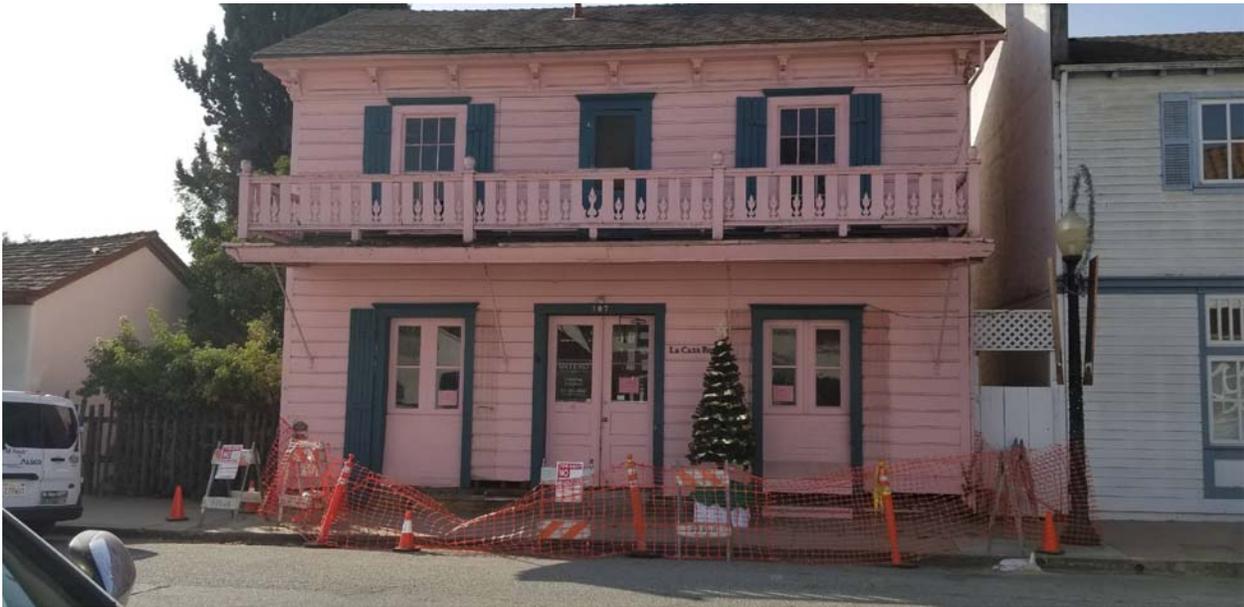
Front Elevation

- Construction on the project was started and then has stopped.
- The large additions in the rear of the property have all been demolished, leaving the rear wall and foundation of the historic portion of the building open, loose plywood has been placed over the opening in the wall.
- The interior finishes in the historic portion of the building have all been removed.
- A large area of the first floor has been removed and a foundation strengthening has been poured along the front wall. No details for this work were provided.

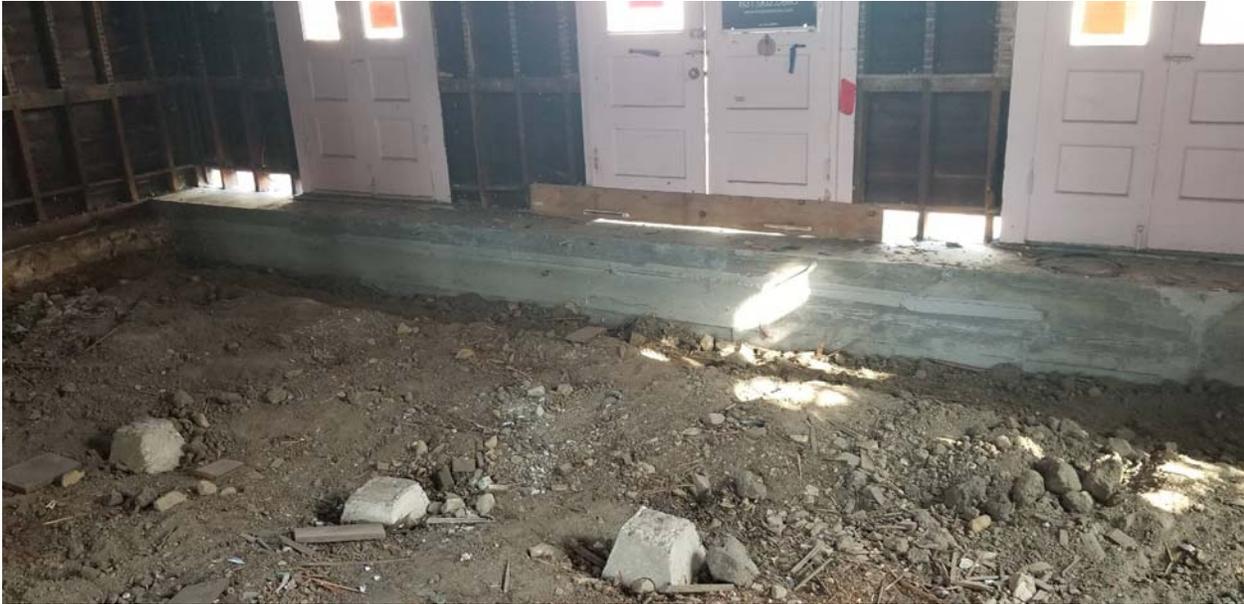
New foundation strengthening at front exterior wall. Note the demolished floor framing.

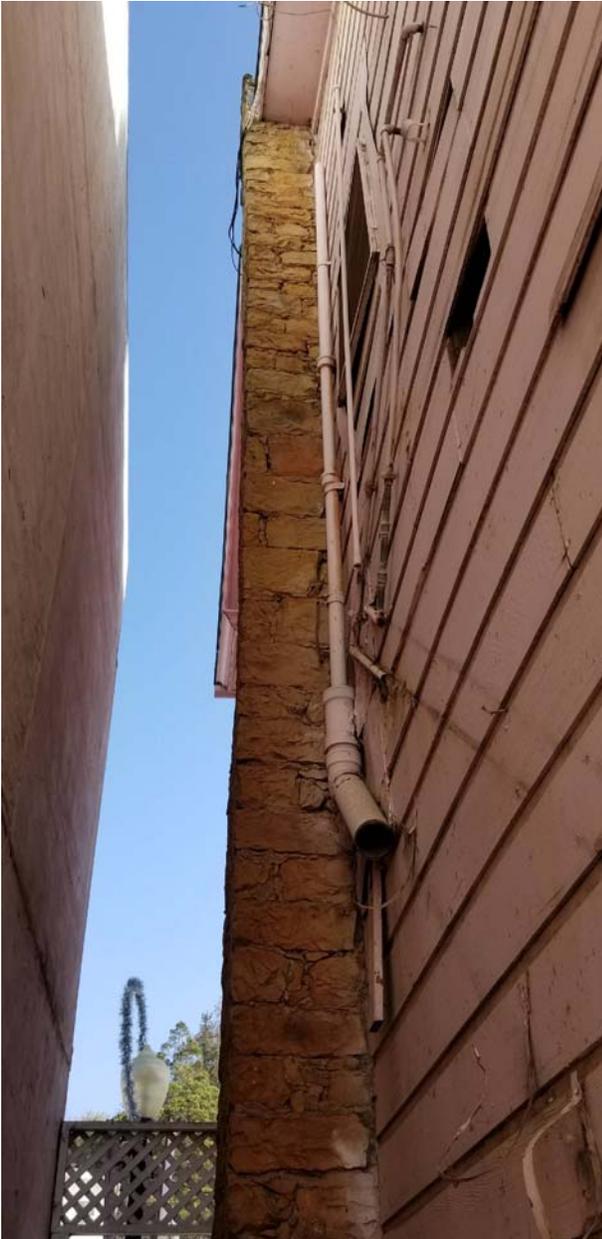
- a. The existing unreinforced chimney is unbraced. The risk to the public is low but in a seismic event it will most likely collapse into the side yard.

Unbraced unreinforced chimney at exterior.

- a. The unbraced unreinforced chimney.
 - b. The rot in the front porch cover/second floor balcony.
 - c. The lack of interior finish. The existing walls are only braced by the existing straight siding. Siding is sufficient to prevent collapse however it is not sufficient to prevent raking of the structure during a seismic event. Steps should be taken to add at least one 4 foot full height panel on each exterior wall and also on the interior wall the runs down the middle of the building. The plywood should be nailed with 10d @ 4" o.c. edges and 12" o.c. in the field.

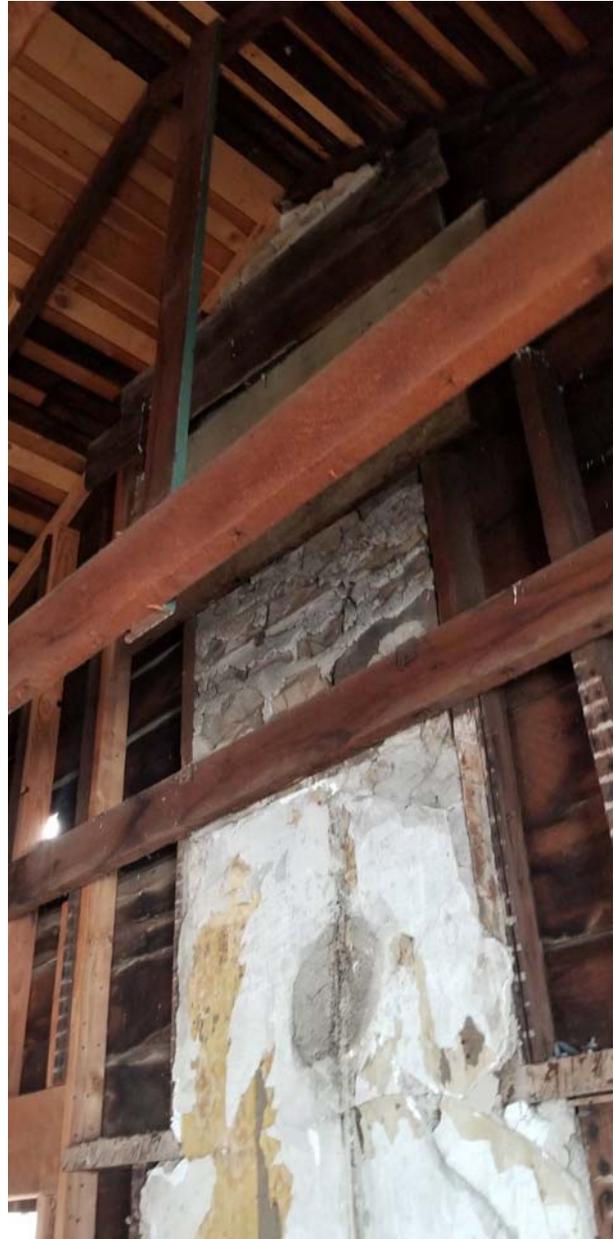
Unbraced unreinforced chimney at interior.

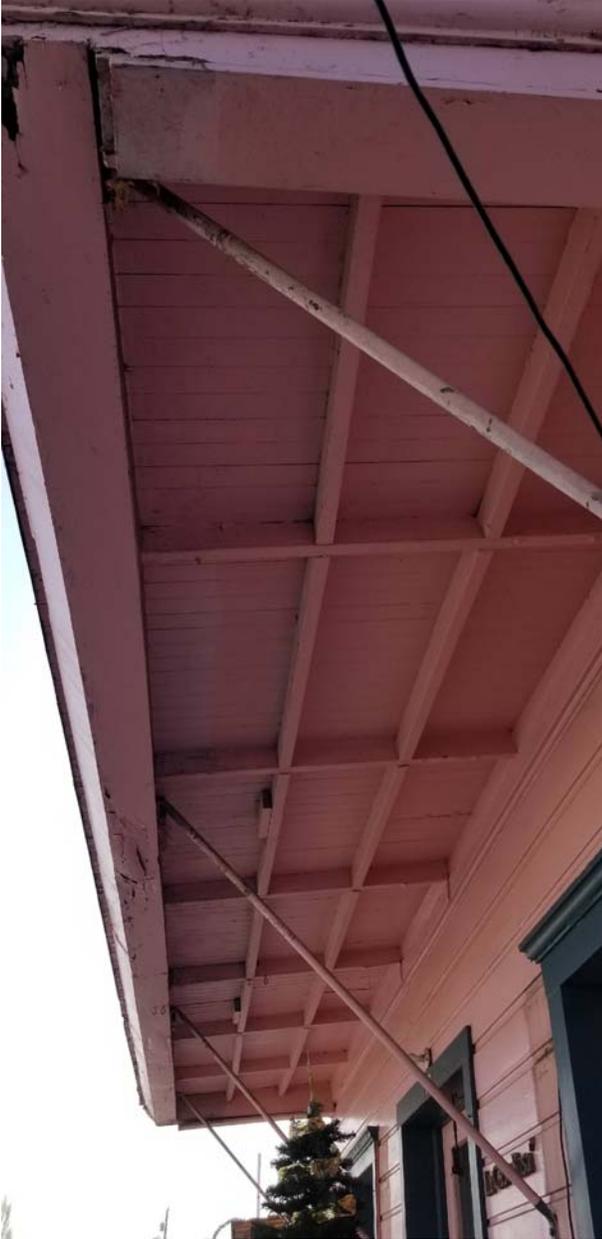
Front Porch Cover/Second Floor Balcony

- b. The front porch cover/second floor balcony is not showing any sign of distress but there are areas of significant rot on the outer edge. This edge is where the diagonal braces attach. The concern is that the deterioration might cause a failure. Since this front porch cover/second floor balcony is over the public R/W it would seem prudent to provide a secondary support until repairs and an engineered solution that allow the structure to remain as it was originally constructed. This is a condition that exists in the front of many of the buildings on Third Street. Most have already provided this type of support. Please see the attached sketches.

- 1) Duquette Engineering should revise their proposed plans for making the public sidewalk safe by incorporating additional measures to secure the balcony. The attachment at the building needs to be addressed. It appears that the balcony is pulling away from the building. When the engineer addresses this with engineered stamped plans, a Building Permit can be issued based on those plans.
